REMOVAL ACTION REPORT

Anderson-Calhoun Mine/Mill Site Leadpoint, Washington

Contract No. 68-SO-1-03
TDD 02-10-0006

March 19, 2003

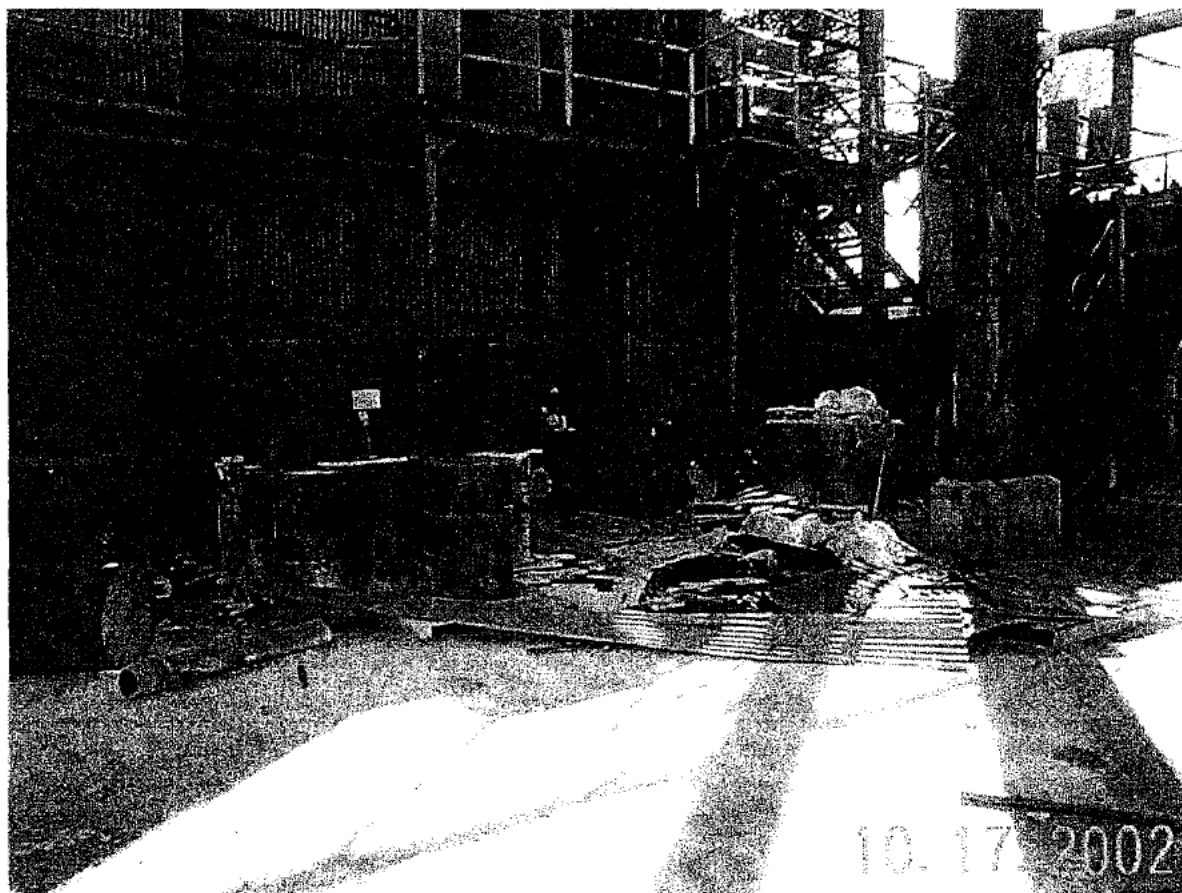
Figure 6). Many of the drums were punctured by bullets, with contents released and solidified onto the concrete foundation. Several auction ticket labels associated with the James G. Murphy, Inc. Auctioneers were noted affixed to various ball mills and other mill processing equipment, as well as on one of the 55-gallon drums (drum #77) staged among a large center grouping of drums at the northeast corner of the building.

A total of 98 55-gallon drums were observed staged together on the first floor (#38 through #115 and #131 through #150). In general, most of the drums contained like substances identified either by labels and container type or from hazard categorization results including six sodium hydroxide powder (#40 through #45), eight liquid base material labeled "Aero-Promoter" (#91 through #97), and seventeen flammable liquid material including eight drums labeled "Super Flocc 1" (#98 through #114). The largest number of drums in the center of the main staging area contained a liquid base material solidified due to cold temperatures identified by labels as "silicate of soda" (#32 through #90 and #131 through #150). Most of the perimeter drums (#32 through #90) were punctured by bullets, with contents released and solidified on the concrete floor. Drums located in the center of the group (#131 through #150) were full of silicate of soda. The 17 remaining drums included five flammable liquids (#38, #39, #47, #53, and #54), three frozen liquid (#55, #57, and #58), six caustic liquid (#46, #48 through #51, and #56); and one sludge (#115). Only drum #52 was empty.

Figure 6. View of the main drum staging area located inside the northeast corner of the mill building, Anderson-Calhoun Mine/Mill site in Leadpoint, Washington.

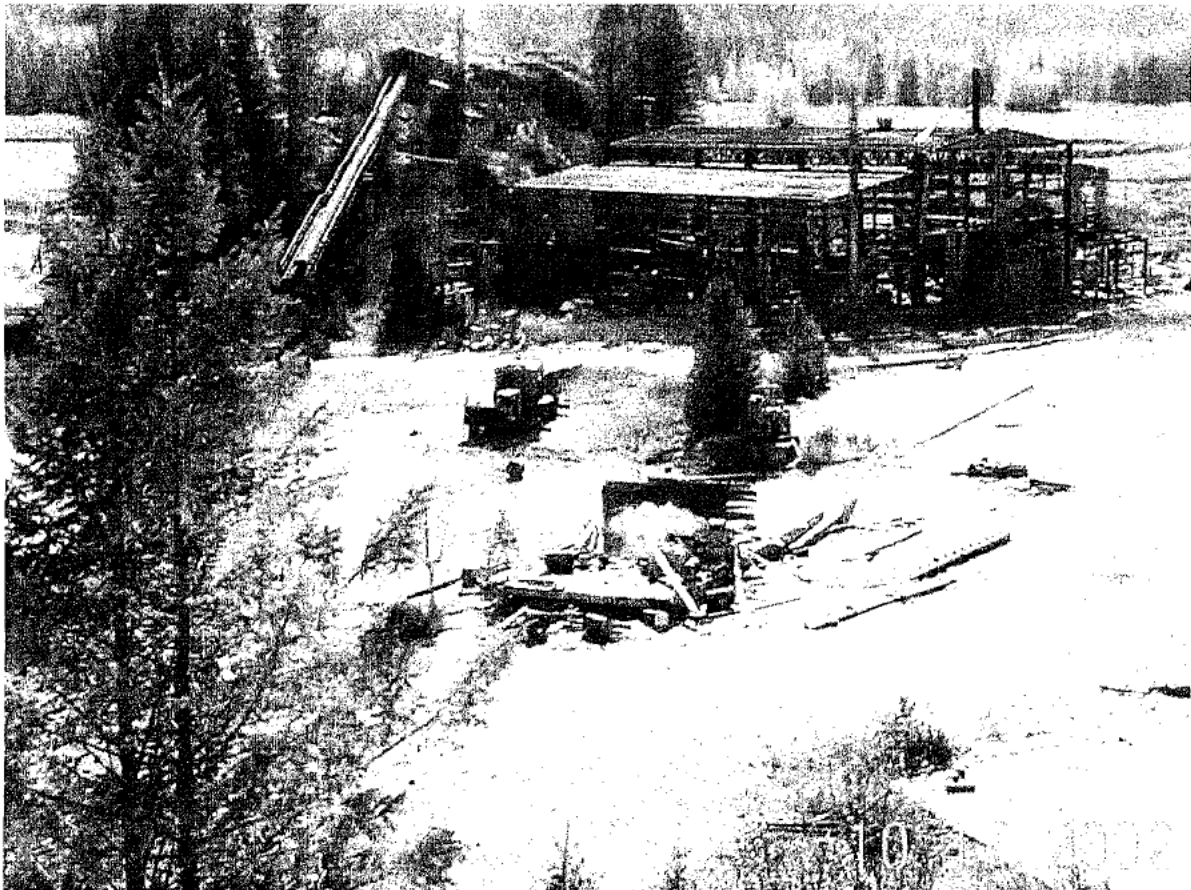
Four 55-gallon steel drums and eight 1- or 5-gallon metal containers (#12 through #23) were located on and surrounding the former wooden shed platform (Figure 7). Eleven of the 12 drums and containers in this area contained sludge, possibly gear lubricant, grease, or dried red-colored paint. Drum #21 was a black steel bung-type drum, with a stenciled label printed on its side “Aero Promoter.” Also observed were eight disposed car and truck batteries on the wooden shed platform.

Figure 7. Panoramic view of the mill site, including the wooden shed platform (center foreground), the mill building (upper right background), and the hill top with the portal/shaft on top just east (left) of the mill building, Anderson-Calhoun Mine/Mill site in Leadpoint, Washington.

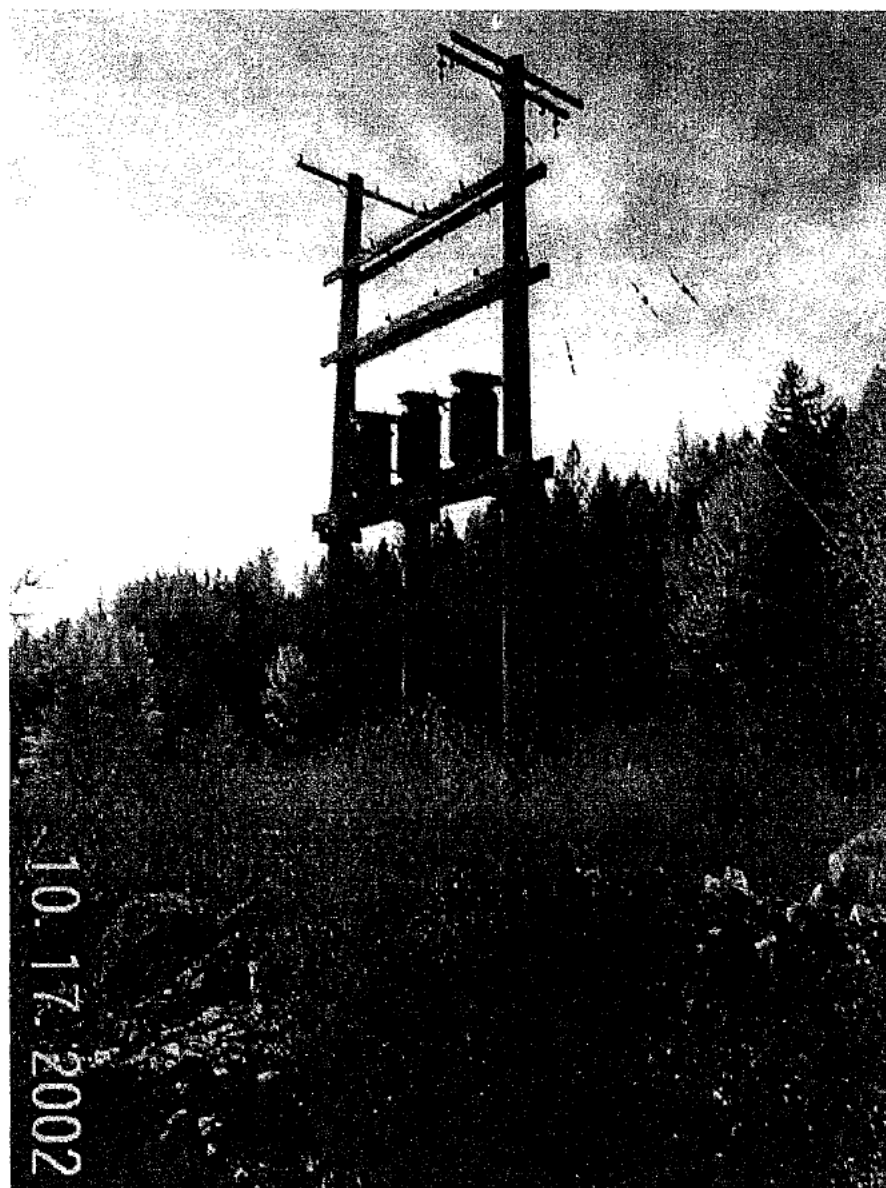
Three large platform-mounted transformers on power poles were observed on top of the hill next to the upper hopper area north of the mill building (T19, T20, and T21). Each transformer had a total oil capacity of 44 gallons (Figure 9).

Figure 9. View of three transformers on a pole-mounted platform (later designated as T19, T20, and T21), view from the upper hopper area looking to the southwest, Anderson-Calhoun Mine/Mill site in Leadpoint, Washington.

- START observed and documented ERRS removal of transformer T21 from the slope using a track hoe. ERRS attempted to remove oil-filled transformer T20 from the same pole-mounted platform as T21; however, oil released from T20 onto the slope below as it was swung over to the staging area (upper hopper area). The OSC and START halted work and revised the work plan to remove pole-mounted transformers by draining oil into drums prior to dismounting them from power poles.

- ERRS drained oil from pole-mounted transformers T19, T26, T27, and T28 into drums, and START collected confirmation oil samples.
- START observed and documented ERRS removal of oil-stained soil from the hill slope where oil released from transformers T20 and T21. A track hoe and hand shovel were used.

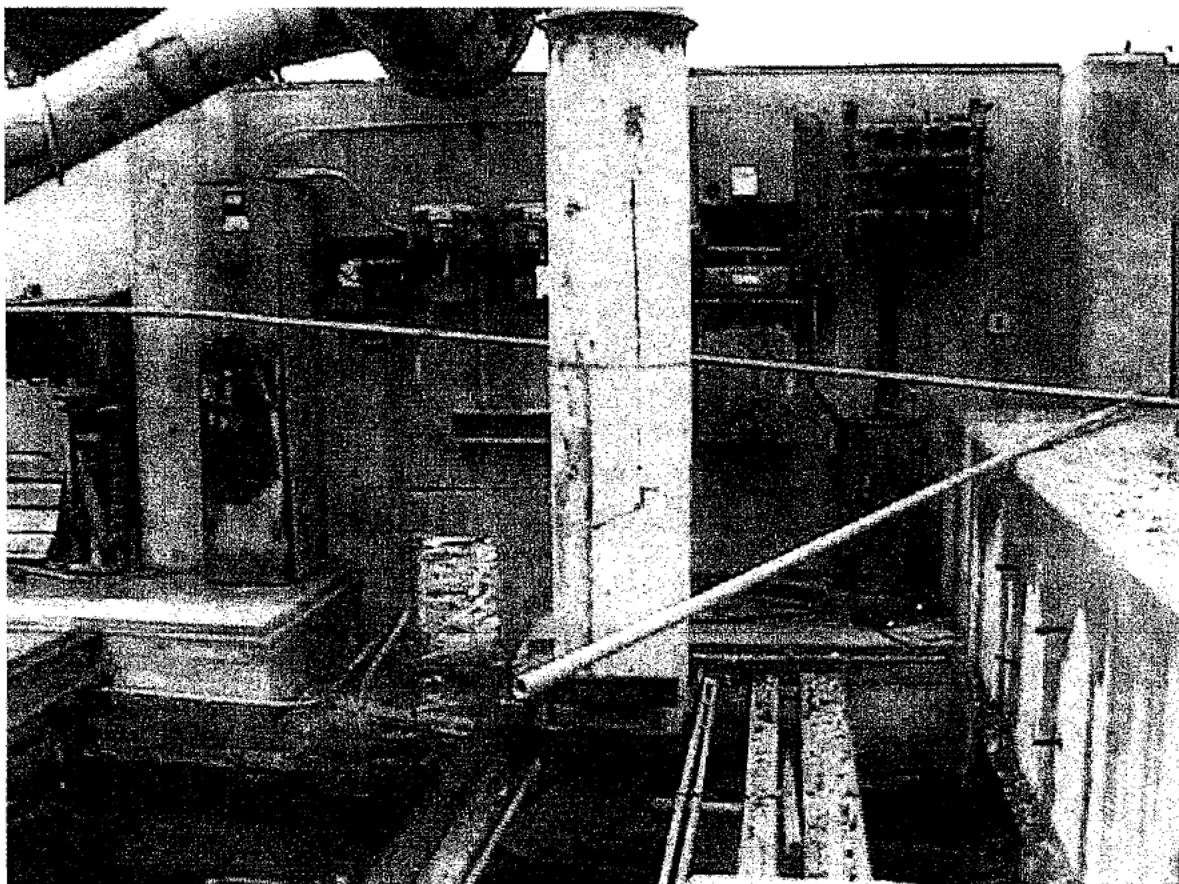
Electrical equipment containing dielectric oil was observed in the lower hopper/primary crusher area (Figure 10), including three oil-filled circuit breakers (T29, T30, and T35; each with an estimated oil storage capacity of 2 gallons), a linestarter (T31; estimated oil storage capacity of 20 gallons), a controller switch (T32; estimated oil storage capacity of 30 gallons), an under-voltage trip switch (T33; estimated oil storage capacity of 2 gallons), and a wall-mounted transformer (T34; estimated oil storage capacity of 5 gallons). Oil staining on the wall and concrete ledge beneath transformer T34 was observed. Another trip switch was observed in this area (T36; estimated oil storage capacity of 2 gallons), but it was empty.

Figure 10. Oil-filled electrical equipment including switches and circuit breakers located in the lower hopper/primary crusher area, Anderson-Calhoun Mine/Mill site in Leadpoint, Washington.
